United States Environmental Protection Agency Environmental Sciences Division P.O. Box 93478 Las Vegas, NV 89193-3478 TS-PIC-20506006S November 2004

AERIAL PHOTOGRAPHIC ANALYSIS OF DEVIL'S SWAMP LAKE SITE Scotlandville, Louisiana

EPA Region 6

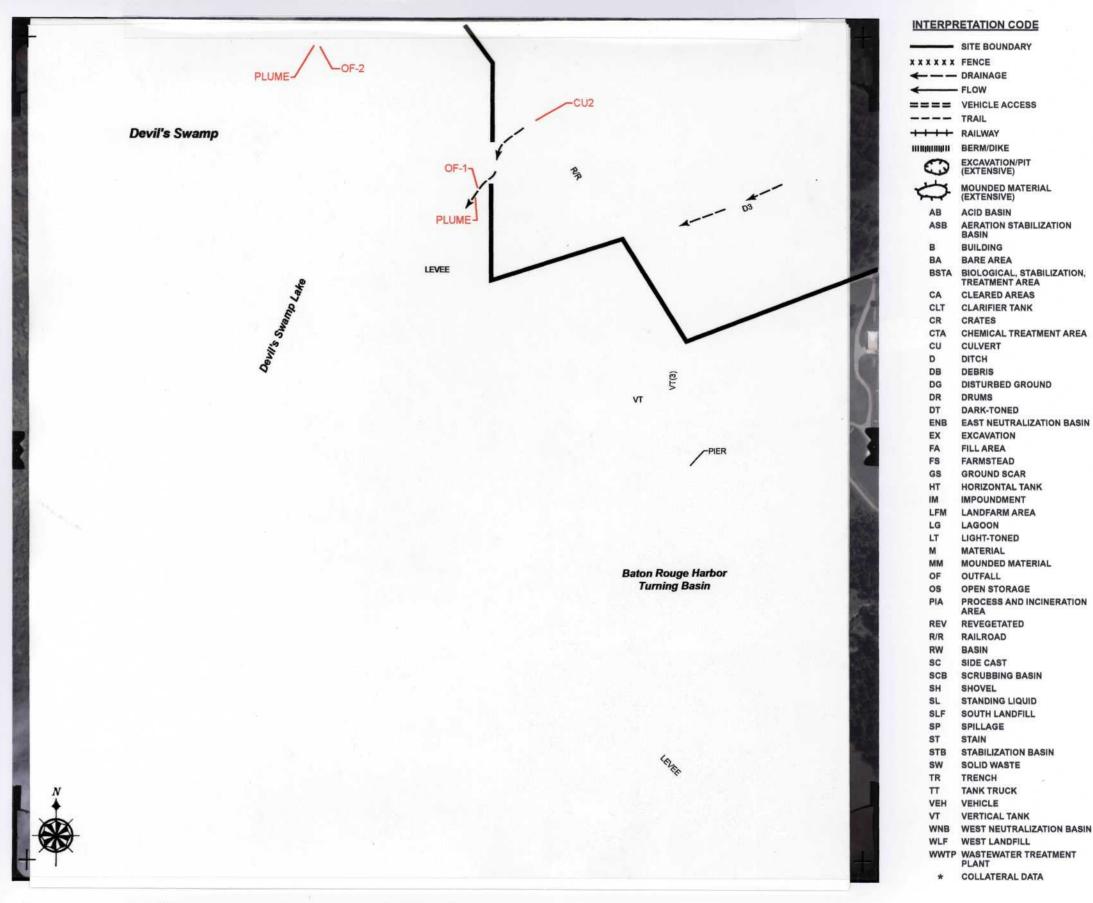
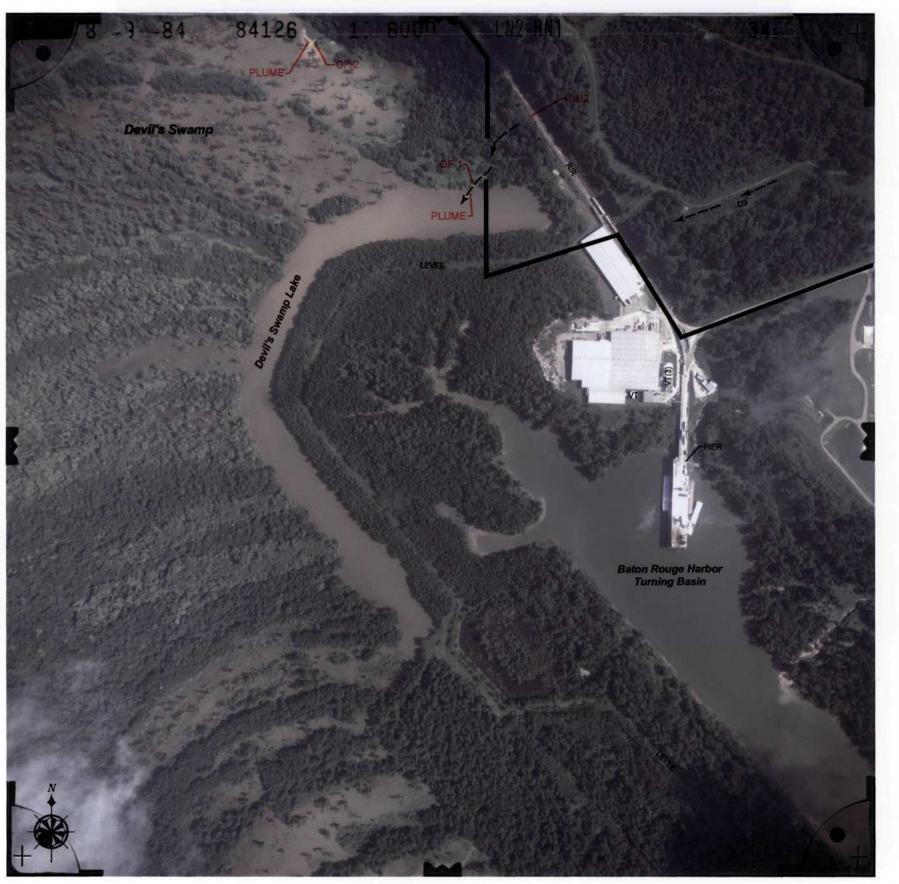
Figure 16. Devil's Swamp Lake area and RES site, August 9, 1984.
Approximate scale 1:6,000.

Devil's Swamp Lake is visible north of the levee protecting the Baton Rouge Harbor Turning Basin. The water in Devil's Swamp Lake appears to have a lighter color compared to the water within the Baton Rouge Harbor Turning Basin. The two light-colored outfall plumes (OF-1 and OF-2) flowing into Devil's Swamp Lake are visible on this photograph (see also Figure 15). The earthmoving activity at the soil-barrow pit has exposed widespread, bare soil along the western side of the WLF. This bare soil is a likely source of silt probably transported into Devil's Swamp Lake.

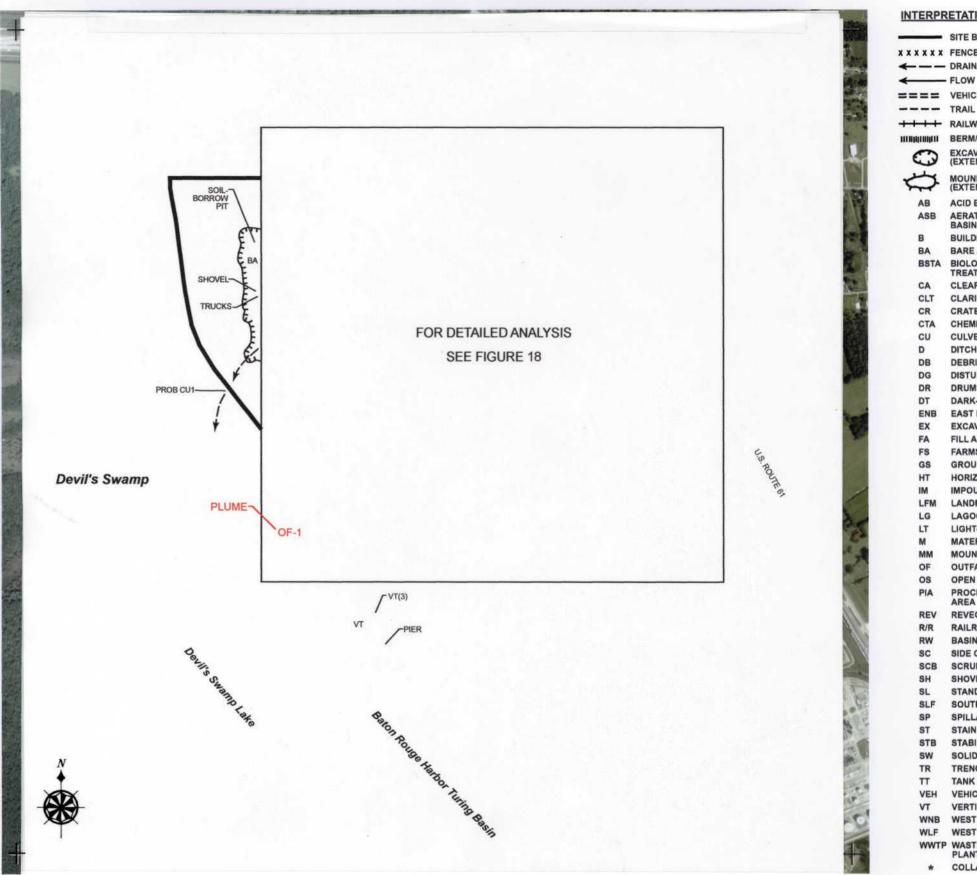
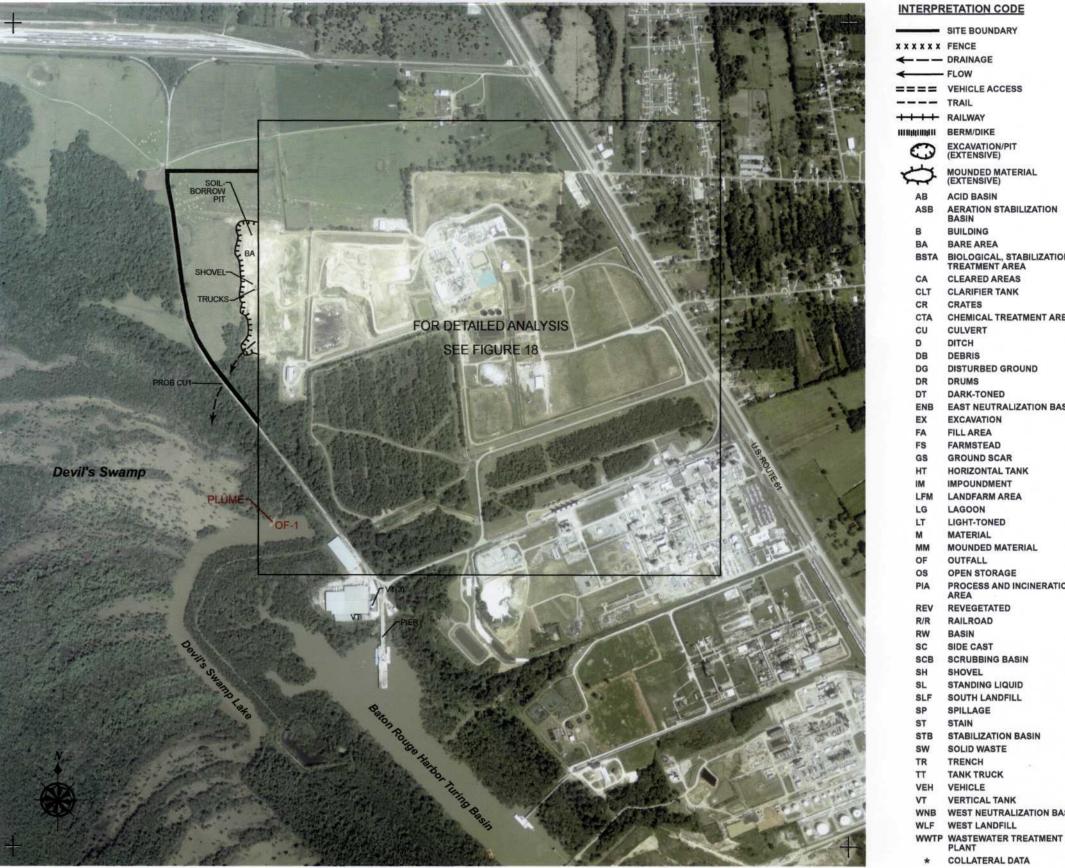
Figure 17. Devil's Swamp Lake area and RES site, April 20, 1988. Approximate scale 1:13,130.

The soil-borrow pit north of the Mixing Facility has undergone more excavation to the west. Bare areas (BA, not all annotated) of exposed soil where the vegetation has been removed are widespread within this soil-borrow pit. A natural drainageway indicates surface runoff from this soil-borrow pit flows southwest and into nearby Devil's Swamp. The light-colored plume from OF-1 is discerned north of Devil's Swamp Lake (see also Figure 18). A portion of this photograph, shown by the annotated square, has been enlarged (Figure 18) to better show the details of features observed at the RES facility.

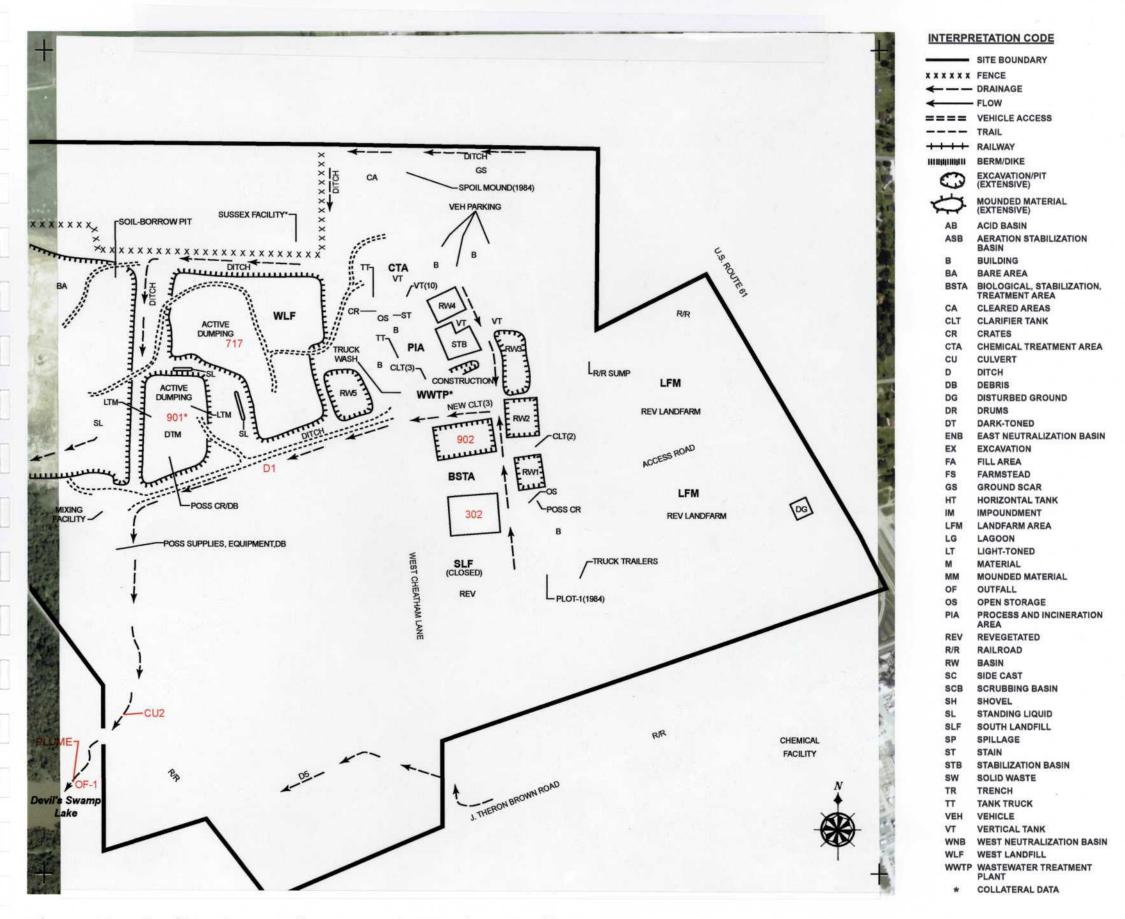
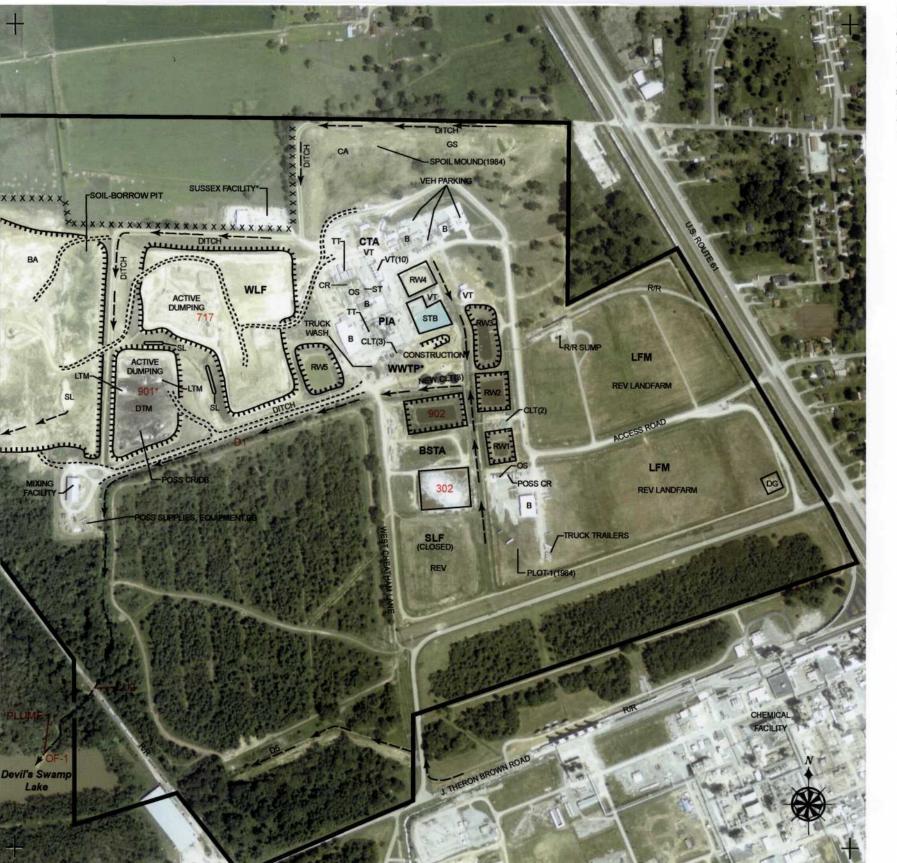
Figure 18. Devil's Swamp Lake area and RES site, April 20, 1988. Approximate scale 1:7,140.

Within the soil-borrow pit west of the WLF earthmoving equipment including shovels (SH) and trucks and a system of unpaved trails are discerned. Accumulations of light-toned standing liquid are observed within the soilborrow pit.

A light-colored plume of outfall OF-1 entering Devil's Swamp Lake remains visible.
